Effectiveness of Driver Speed Awareness Signs in Suburban Speed Transition Zones

ITE District IV Meeting
Rochester, MN
June 14-16

Ted Schoenecker, P.E. – Washington County
Kristi Sebastian, P.E. – Dakota County
Dan Soler, P.E. – Ramsey County

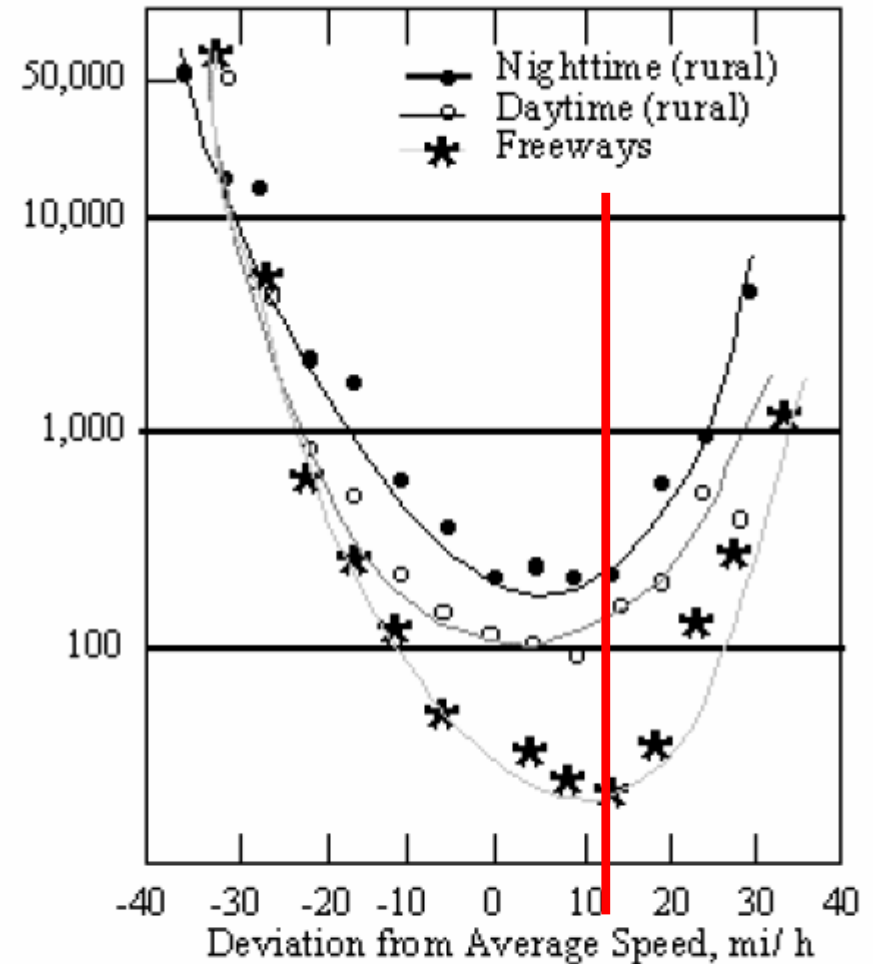
Figure 1. Crash involvement rate by deviation from average travel speed (from Solomon, 1964, and Cirillo, 1968).

- Safest speed is speed that majority of drivers drive
- 85% speed as the important factor.

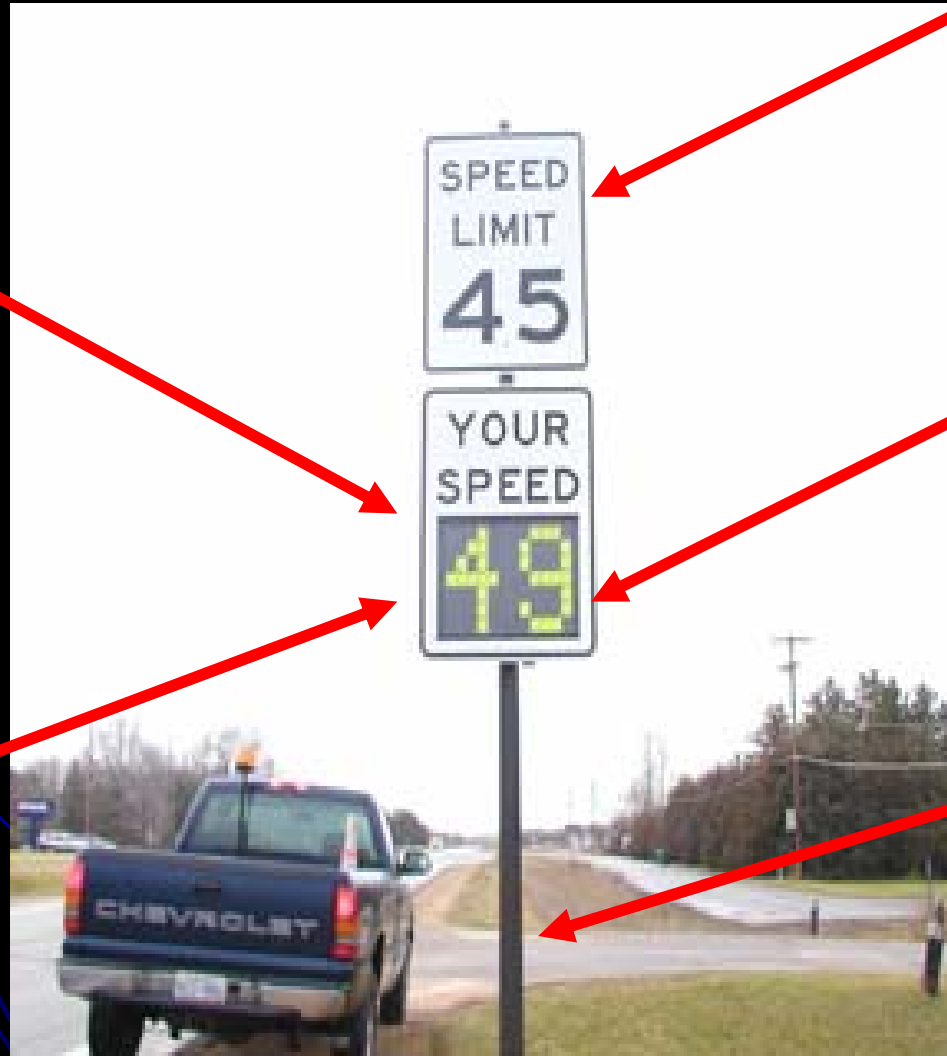
Below
Regulatory
Sign

Flashes if
Over Limit

Permanently
Mounted

Lakeland Location – 50 mph to 45 mph

Display
Actual Speed

Driver Speed
Awareness
Sign

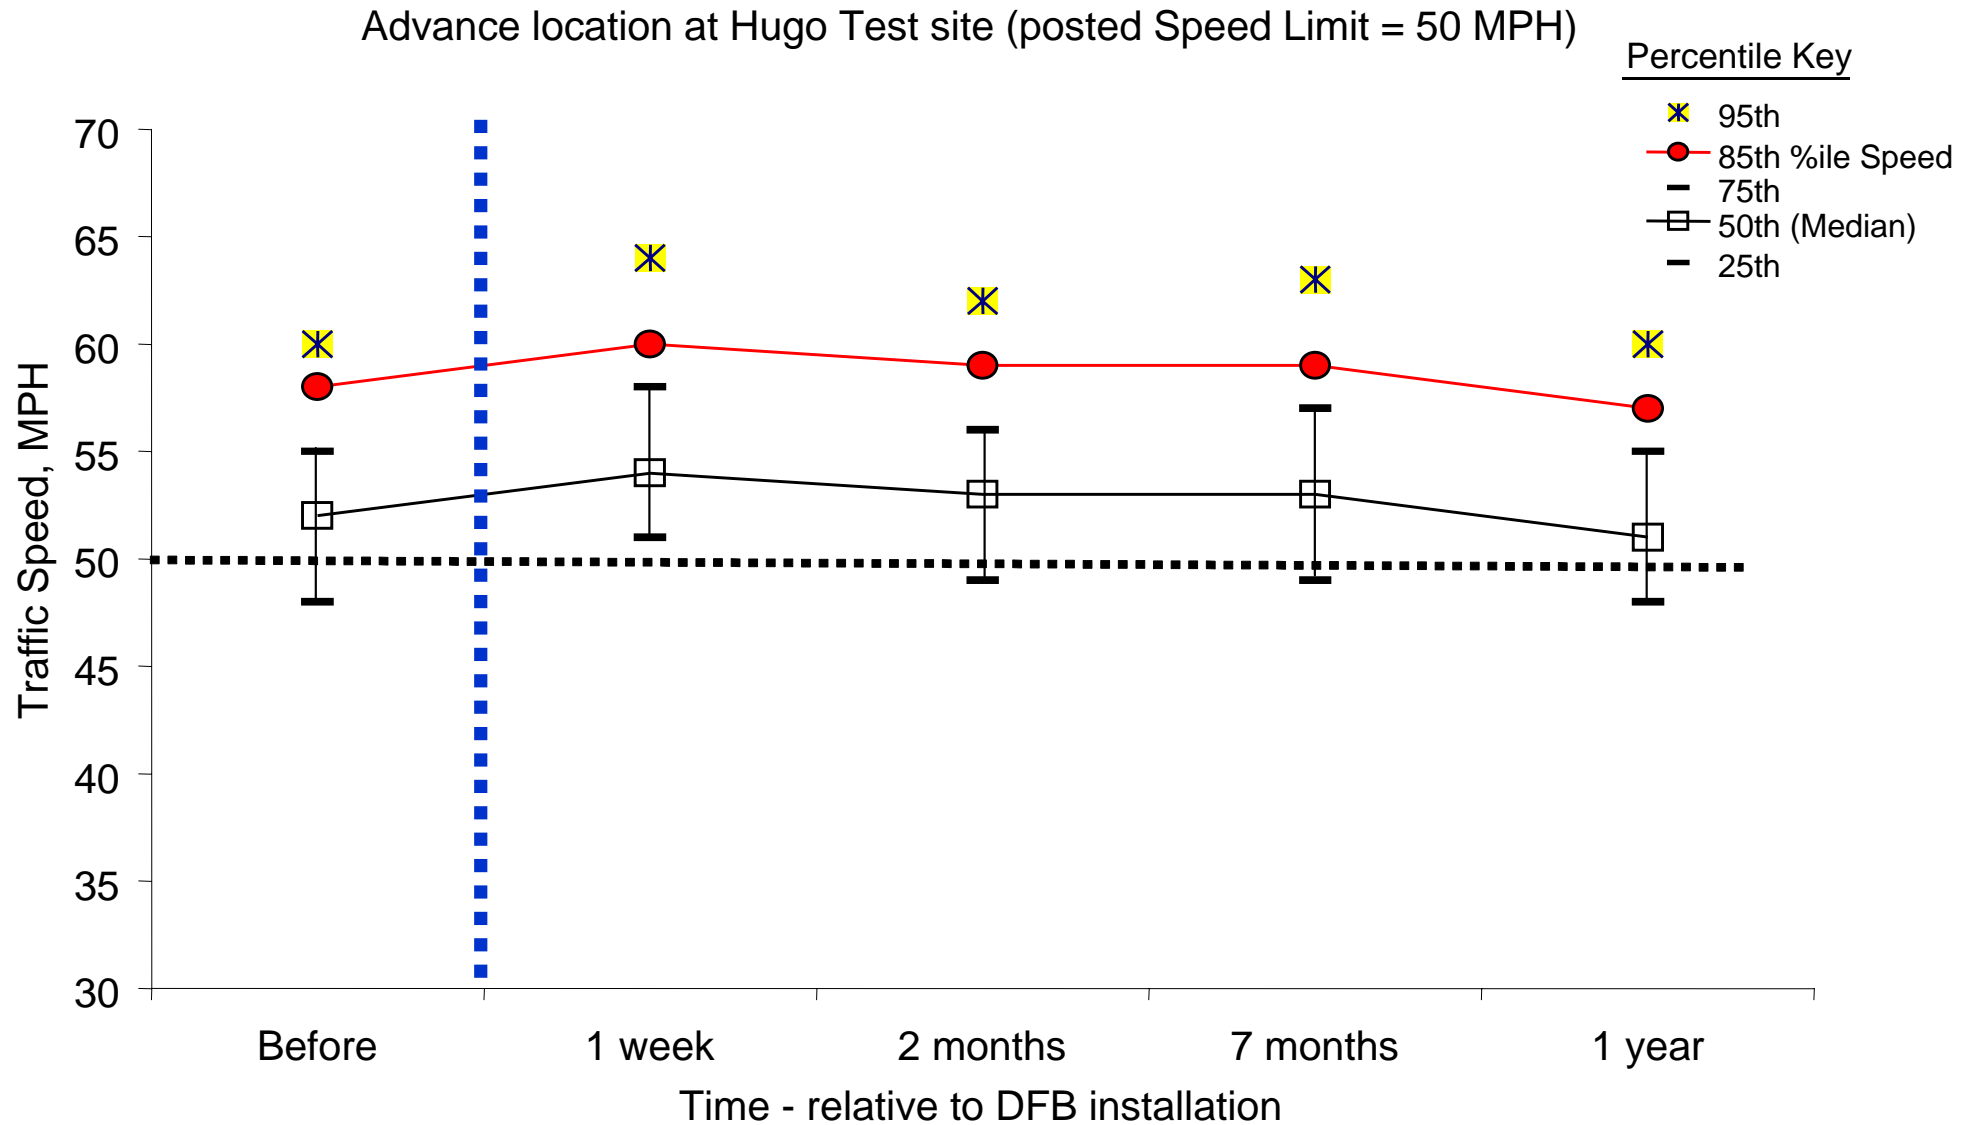
Hugo Results – Advance Location

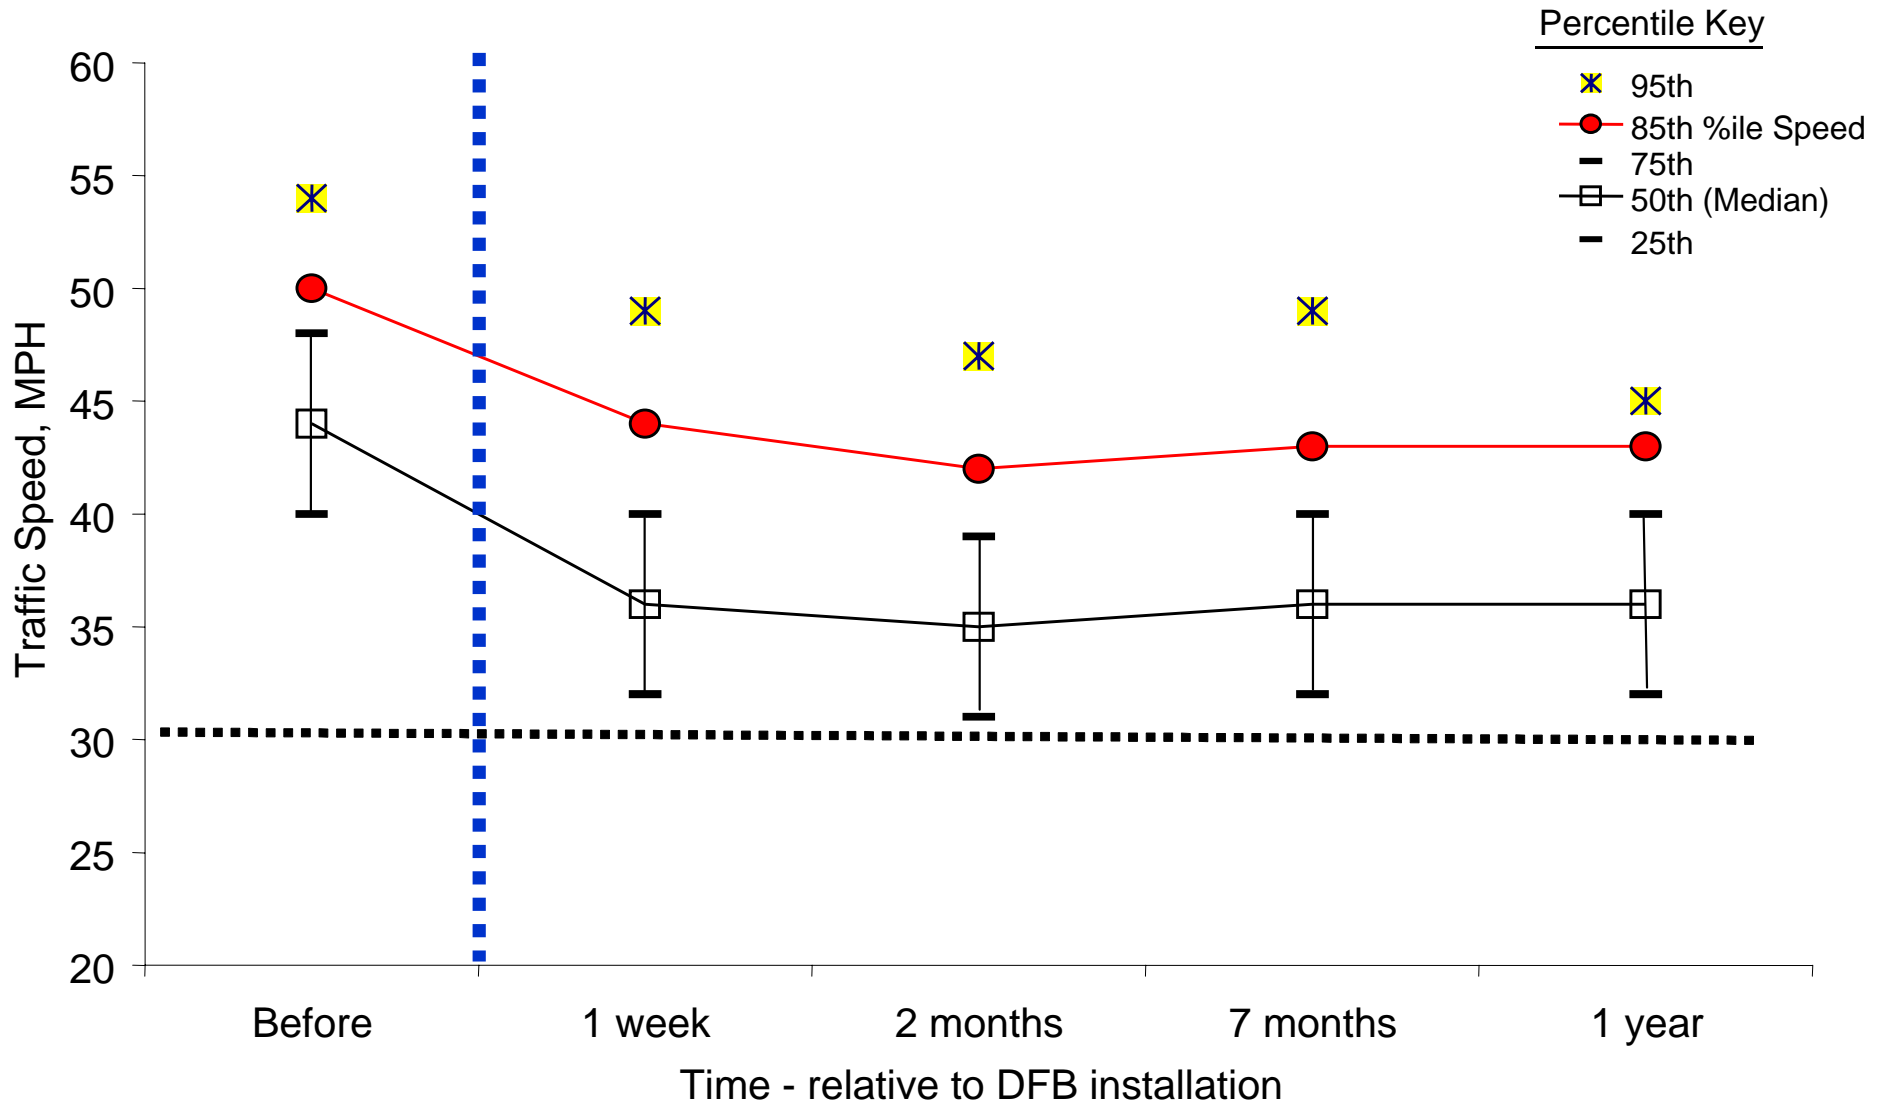
Hugo Results – At Sign

DFB location at Hugo Test site (posted Speed Limit = 30 MPH)

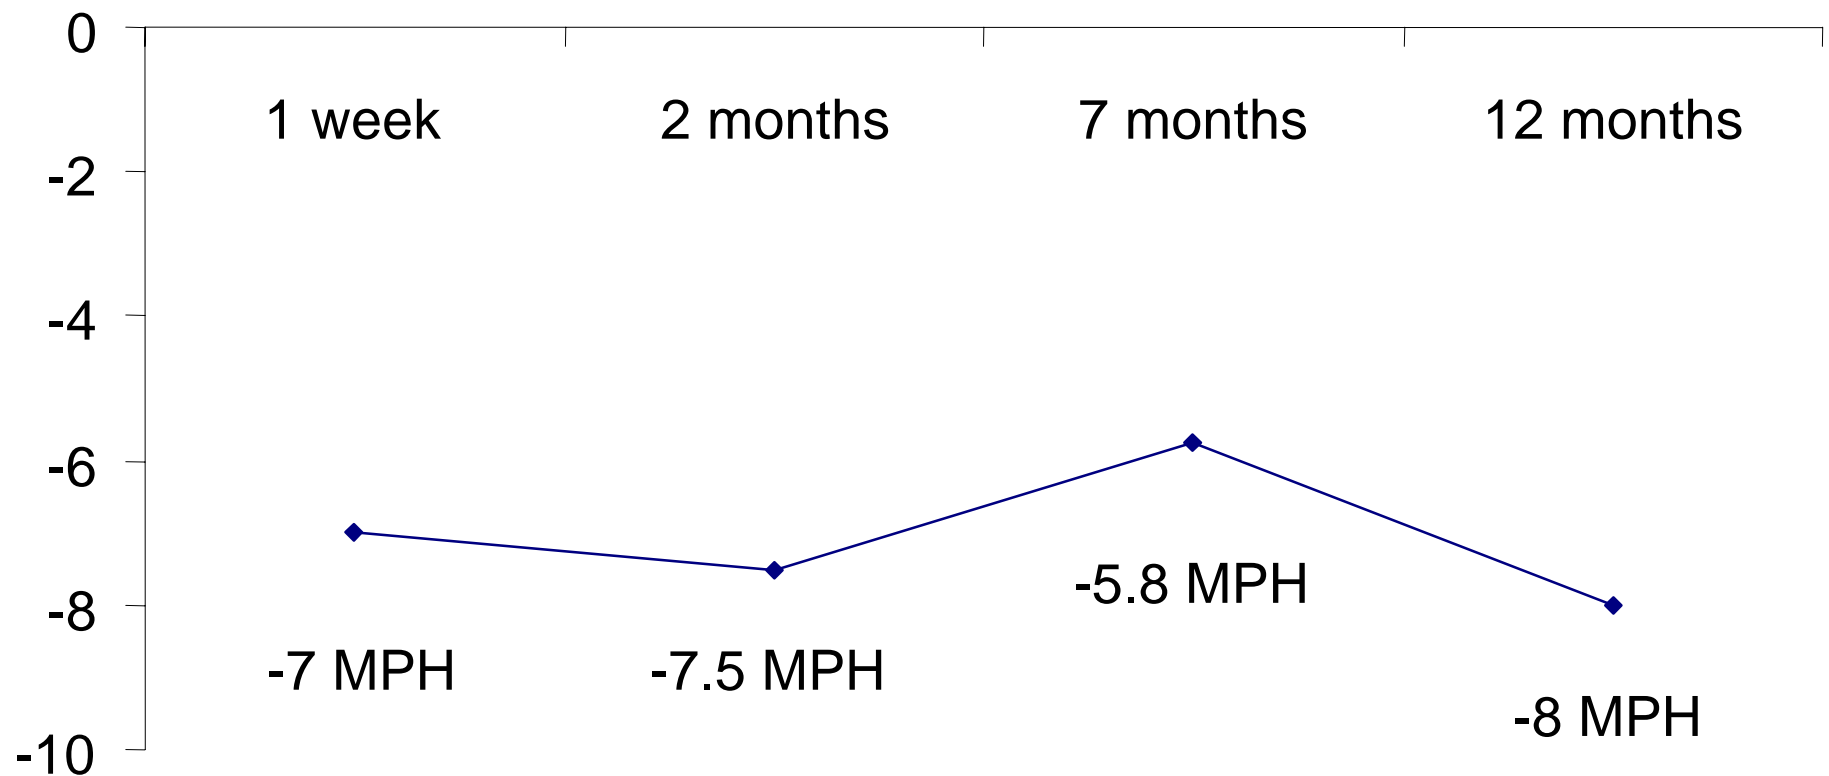
Study Results – Summary of Four Locations

Average Change in 85%ile Speed After Installation

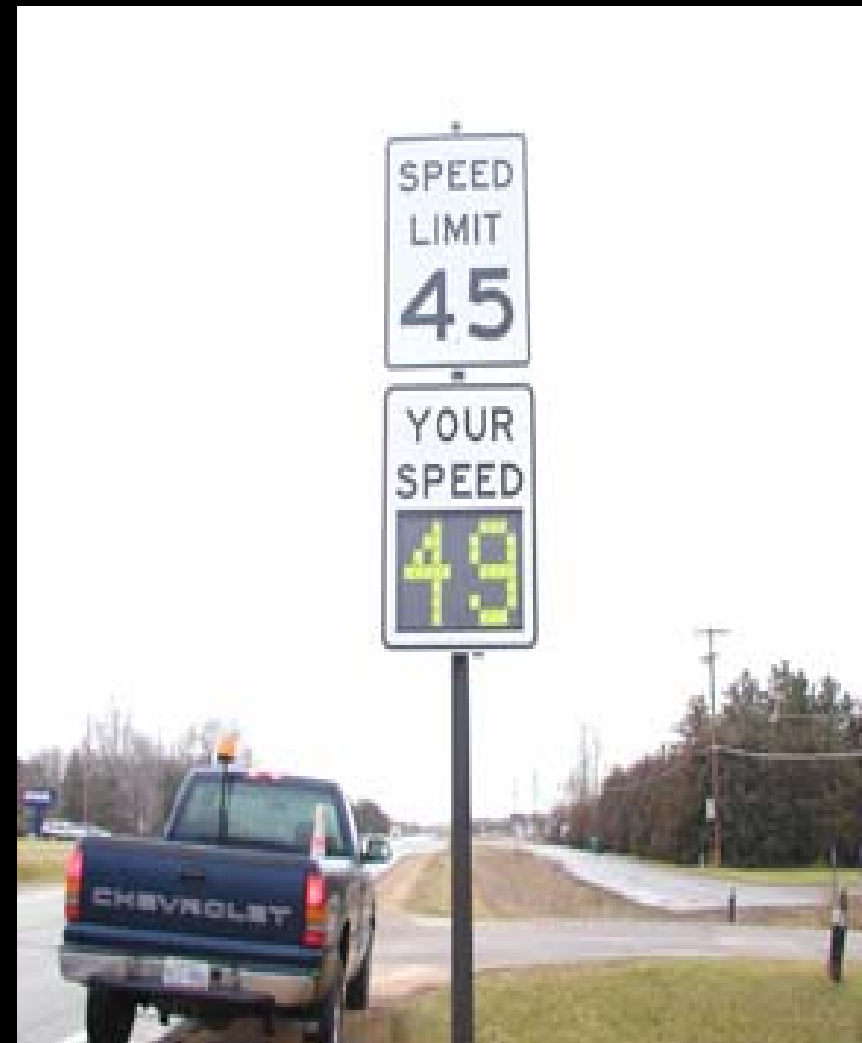
- Screw Pole Base
- Pedestal Pole Mount
- Requires Licensed Electrician
- Sign Mounted on Pole – “Aiming”
