An Evaluation of Illuminated Pedestrian Push Buttons in Windsor, Ontario

REPORT NO. FHWA-RD-00-102

August 2001

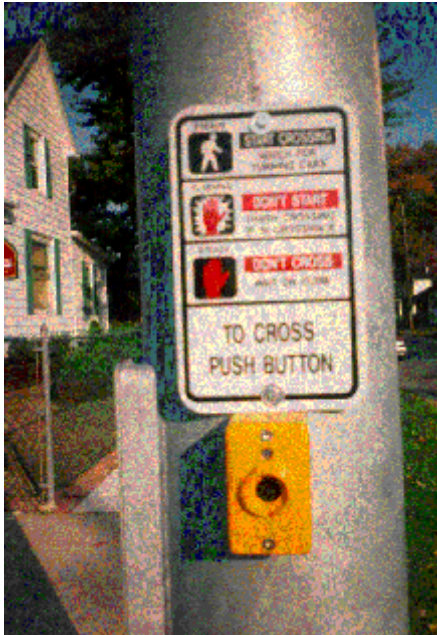
Figure 1. An illuminated push button in Windsor. The orange light is below the button.

The illuminated push button device that was evaluated in this study is the accepted design being used at hundreds of intersections in Canada. It has only a small orange light that may be difficult for pedestrians to see, particularly in the sun’s glare.

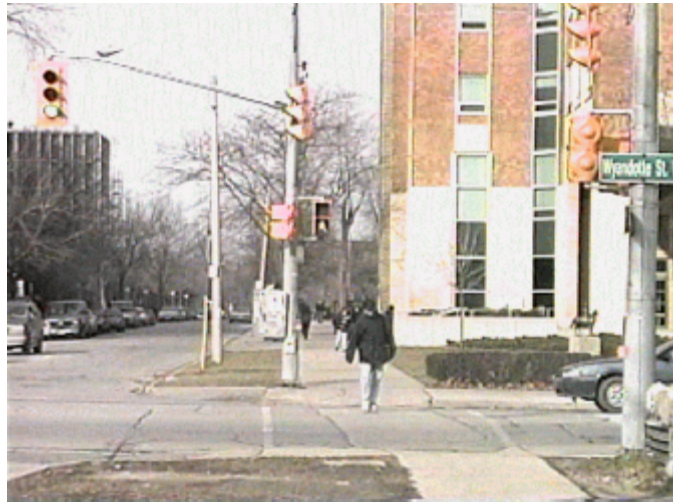
Figure 2. A view from the video camera, Wyandotte at Sunset, east crossing.

A video camera was used to record pedestrian and motorist behavior at all locations. The video camera was set up on the sidewalk along the side street, approximately 23 m (75 ft) upstream from the intersecting main road. The camera faced in the same direction as traffic on that half of the side street. This position enabled the camera to record, on videotape, pedestrians in the crosswalk as they were crossing the main road, and those waiting in the queuing areas on either side of the main road. The camera also recorded signal phases for traffic on the side street and pedestrian phases for pedestrians crossing the main road (Figure 2).

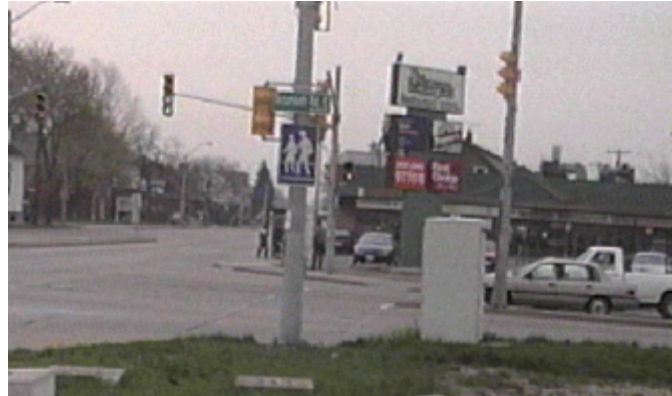
Figure 3. Tecumseh at Howard, west leg.

This is an intersection of two arterials (Figure 3). Tecumseh Road has five lanes, including the left-turn-only lane. The ADT is 26,000 and the speed limit is 50 km/h (31 mi/h). Both the east and west legs of Tecumseh have refuge islands. A high school is located near the southwest corner of Tecumseh Road and Howard Avenue. In addition, another school is three city blocks west of Howard, so many students who go to that school pass through the intersection of Tecumseh and Howard. Not surprisingly, most pedestrians at this intersection were students.

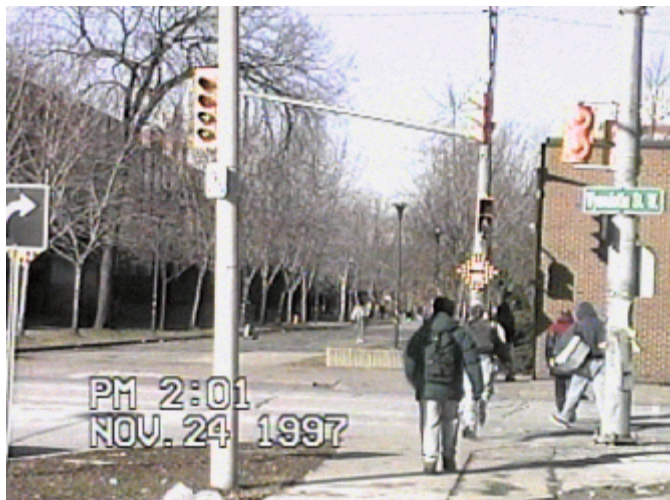
Figure 4. Wyandotte at Patricia, east leg.

Patricia Road is a north-south collector street two blocks to the west of Sunset. This is a T-intersection, and Patricia forms the south leg of the “T.” (Figure 4) At the intersection, Wyandotte has four lanes. The ADT on Wyandotte is 12,100 and the speed limit is 50 km/h (31 mi/h). The east leg of Wyandotte (but not the west leg) has a marked crosswalk and a pedestrian signal. The southside crosswalk is extra long, as pedestrians cross both Patricia and a bridge on-ramp, which is separated from Patricia by a raised median. The University of Windsor campus is to the north of Wyandotte. A mix of University buildings and single-family residences is to the south of Wyandotte. Pedestrian activity was steady during the periods of data collection.

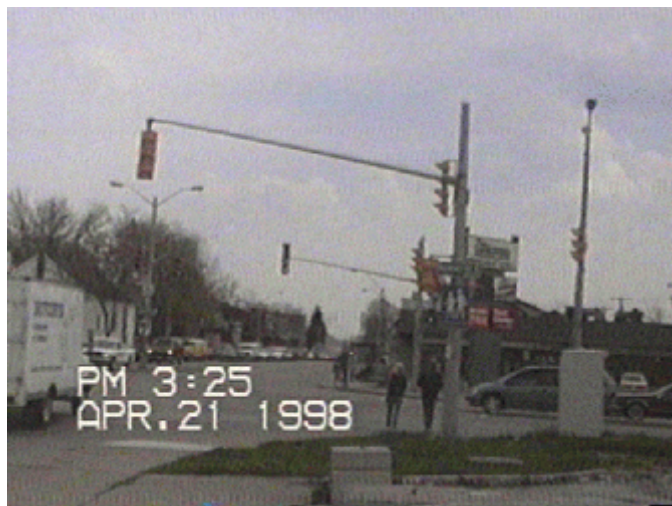
Figure 5. Pedestrians complying with the Walk signal, Tecumseh at Howard, west crossing.

For this analysis, observations were made of pedestrians who arrived when parallel traffic had the red signal and when someone had pushed the button. Pedestrians complied with the Walk signal if they waited until the Walk indication appeared before starting to cross (Figure 5). Pedestrians may start crossing early, before the Walk signal appears, if they see a gap in traffic or if they believe that the button does not work and the Walk signal will not appear. Table 4 shows the number and percentage of pedestrians who arrived when parallel traffic had the red signal and who waited for the Walk signal to cross.

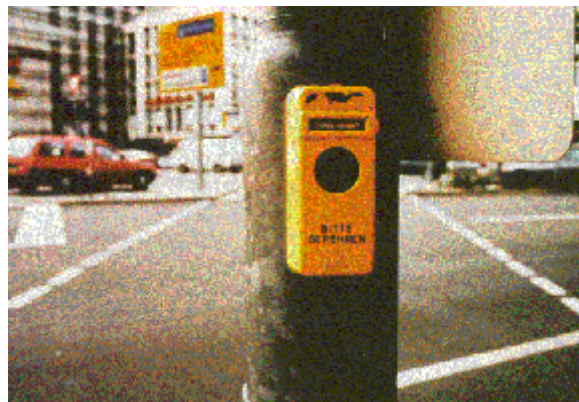
Figure 6. A pedestrian push button displaying the message “SIGNAL KOMMT” (signal is coming). (FHWA Study Tour, 1994).

A more visible acknowledgment or an audible message may be more effective. For example, some push buttons in Germany display a lighted message, “SIGNAL KOMMT” (translates as “Signal is coming”) when the button is pushed (Figure 6). Other push buttons emit a soft ticking sound that varies in speed according to how much longer before the WALK signal appears (FHWA Study Tour, 1994).

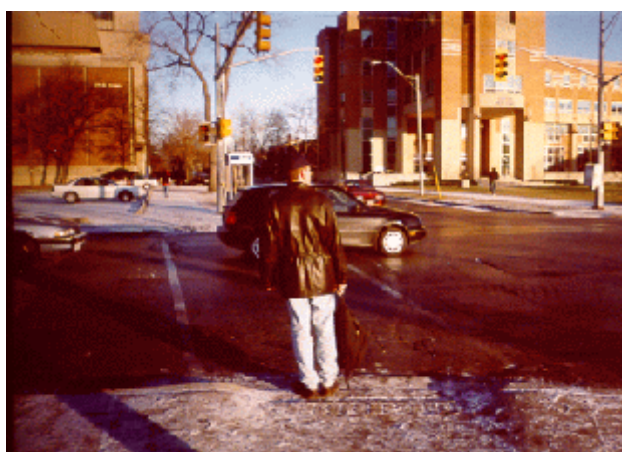
Figure 7. This pedestrian is waiting for the Walk display, but many pedestrians do not wait.

Even if pedestrian signals are activated more consistently (through the use of illuminated push buttons, automated detection, or recall), there is no guarantee that pedestrians will comply and wait for the Walk signal (Figure 7). An immediate Walk signal (a "hot" button), or at least a shorter delay between activation and the appearance of the Walk signal is likely to improve compliance, but can disrupt intersection operations if the signal is frequently activated. Education can help improve compliance. For instance, an informational sign could explain what pedestrians should do during the Walk, flashing Don't Walk, and steady Don't Walk intervals (Figure 1). Stricter enforcement of pedestrian compliance would also result in fewer people crossing against the signal. Better enforcement of driver compliance to traffic signals (e.g., red light cameras) may also be effective in improving pedestrian safety at signalized intersections.
